A Summary of a NIOSH fire fighter fatality investigation

October 24, 2001

Motor-Vehicle Incident Claims the Life of a Volunteer Assistant Chief - Alaska

Fatality Assessment and Control Evaluation Investigative Report #F2001-17

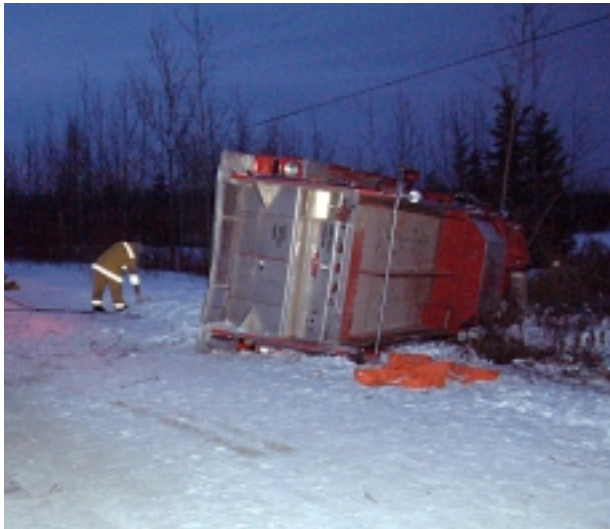
Incident Site

The site of the incident is a gravel road measuring 28 feet in width with no shoulders. The incident site is 2.2 miles north of the intersection of a paved county road and 337 feet south of the driveway to the structure fire. The engine struck a tree (measuring 12 inches in diameter) located 12 feet from the edge of the road (See Diagram). The incident site has a posted speed limit of 50 mph. The engine involved in this incident is an 18 year-old Class-A pumper that measures 8 feet wide and 25 feet long. The engine has a square-shaped 1,000-gallon water tank, not equipped with baffles. The engine is equipped with air brakes. The gross vehicle weight is 27,500 lbs, and at the time of the incident, the water tank was full, which added 8,500 lbs to the total weight of the engine. An inspection of the engine was completed by the state police, and no mechanical problems were identified as a contributing factor to this incident. At the time of the incident, the weather was reported as being cloudy with a temperature of 34° F. The road was covered with a thin layer of ice on top of packed snow.

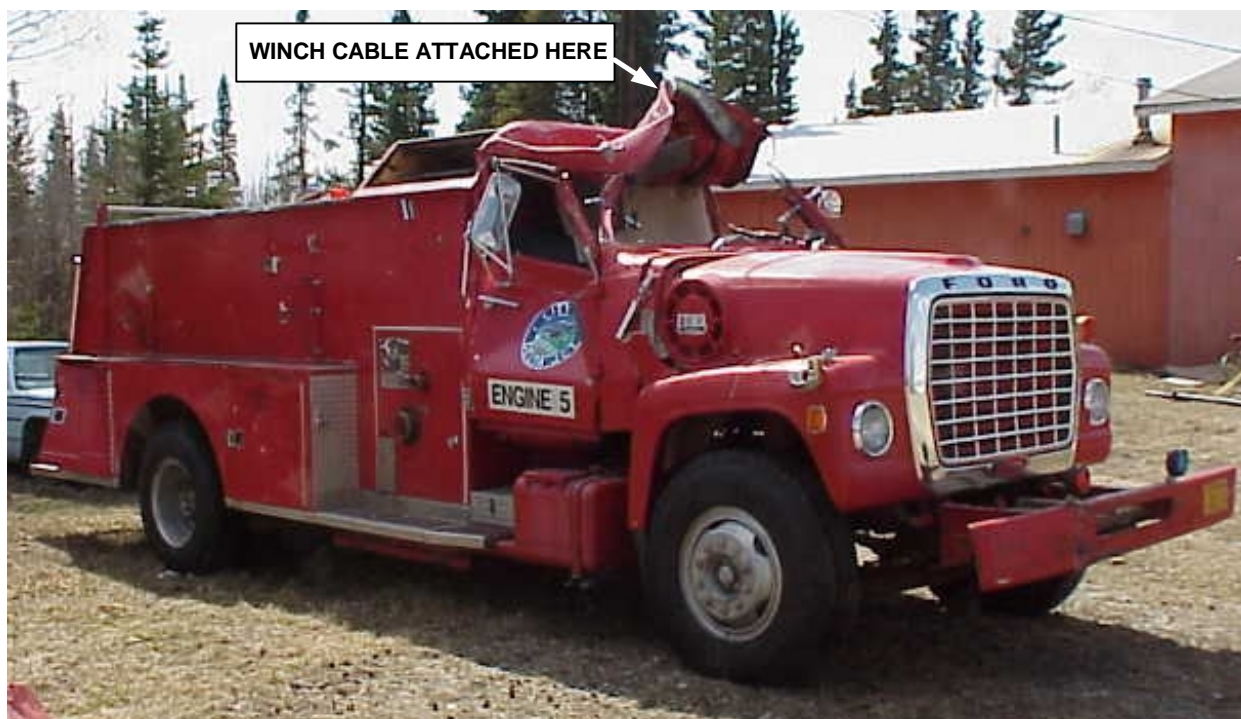
Photo 2. Engine 5

On March 6, 2001, a 41-year-old male volunteer Assistant Chief (the victim) died after the engine he was driving left the road, overturned, and struck a tree. The victim (driver) and a fire fighter had responded in Engine 5 at 1445 hours to a structure fire. At 1503 hours, the victim lost control of the engine on an icy, snow-packed gravel road. The engine left the road, overturned onto the passenger's side, and struck a tree. The victim was thrown into the passenger's side, landing on top of the fire fighter. The victim was entrapped and had to be extricated from the vehicle. Emergency Medical Technicians performed cardiopulmonary resuscitation (CPR) on the victim for approximately 20 minutes before pronouncing him dead at 1530 hours at the scene. The fire fighter (passenger) was able to climb out of the cab and was provided medical attention to ensure that he had not sustained any serious injuries. NIOSH investigators concluded that, to minimize the risk of similar occurrences, fire departments should

Recommendation #2: Fire departments should ensure that apparatus equipped with water tanks are provided with baffles to control the water's movement.²

Discussion: Apparatus equipped with water tanks should follow the provisions set forth in NFPA 1901, Standard on Automotive Fire Apparatus, Chapter 17. This standard states that all apparatus equipped with water tanks should be baffled or have swash partitions to form a containment to control water movement.
